## Hither Creek Washover and Salt Marsh Monitoring

Nantucket Conservation Foundation

January 2019

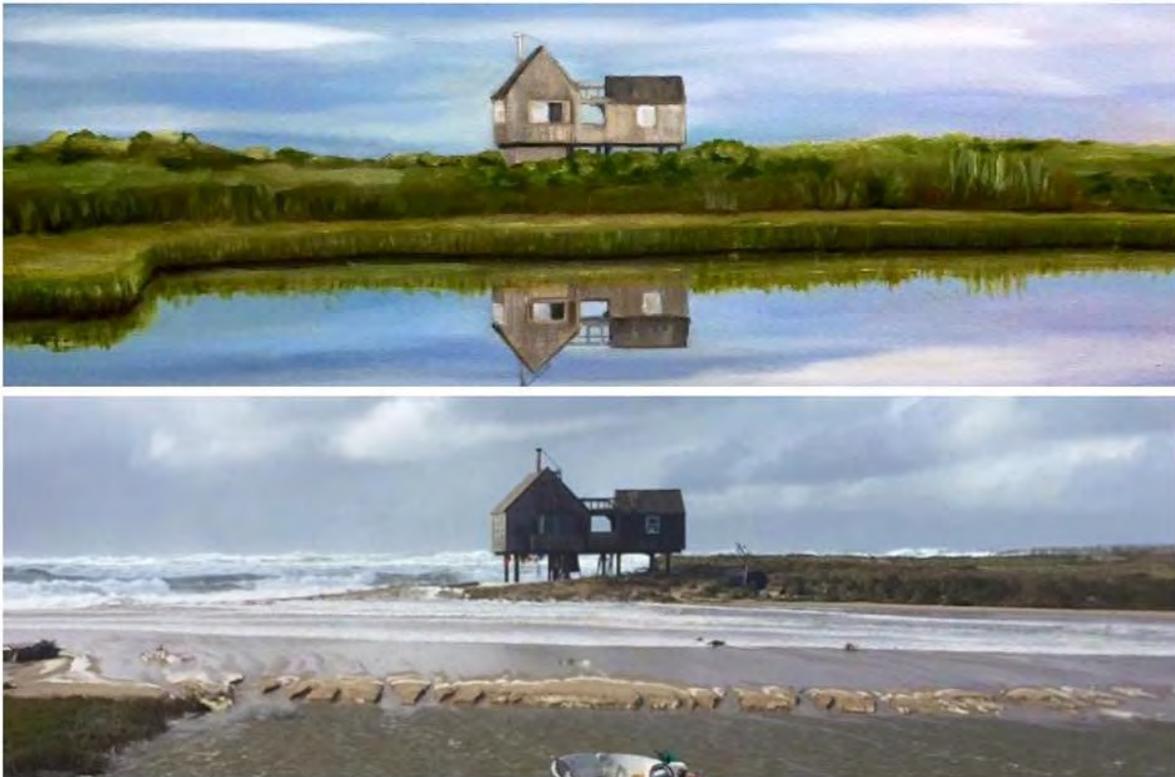
**Figure 1:** Top image depicts Millie's Pond, surrounding vegetation and the Stilt House prior to the October 2017 Storm (painting by Karen Allen-Kelley). The Bottom image was taken during the October storm and shows the dune erosion, deposited sand and overwash from the Atlantic Ocean (photo by Fabrizia Lu Macchiavelli).

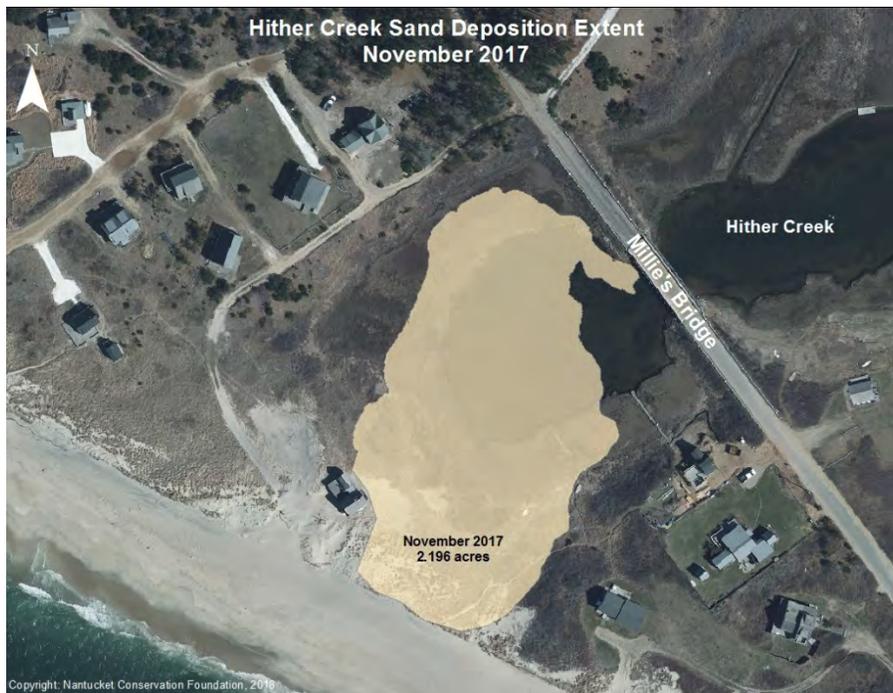
Immediately following the October 2017 storm event, we used a GPS unit to document the extent of sand coverage on and around Millie's Pond during a low tide cycle. Documenting at low tide allowed us to capture the maximum extent of exposed sand collected within the previously open Pond. The initial sand extent in November 2017 covered 2.196 acres from the top of the previous dune and down into the pond (Figure 2).

**Figure 2:** The tan area represents the extent of new sand covering previous shrub wetland, salt marsh and open water at Hither Creek and Millie's Pond, November 2017.

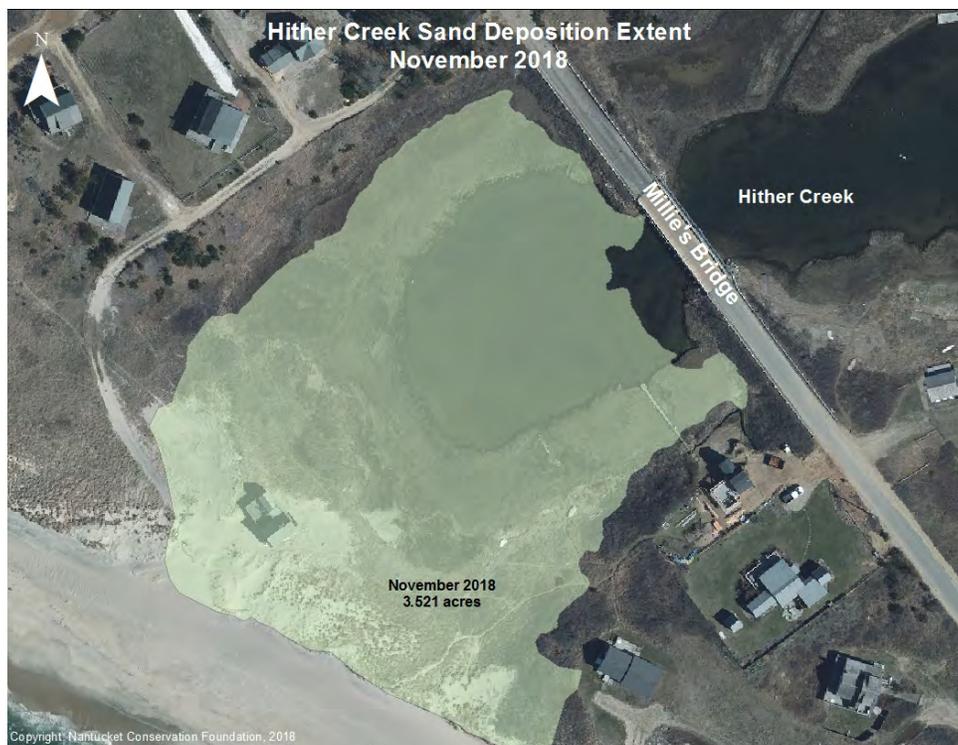
Through settling, erosion and further washover events in the winter of 2018, the sand coverage advanced further into Millie's Pond as well as covering more of the bordering salt marsh areas. Storms in March of 2018 caused the next largest loss of habitat through sand burial. By November 2018, a year after the initial storm event, the sand extent was 3.521 acres (Figure 3) and the Stilt House, still seen in aerial photos, was removed due to the eroding dune.

**Figure 3:** Sand extent at Hither Creek and Millie's Pond after 1 year. Daily tides and additional storm wash-overs caused the initial sand deposits to shift and migrate over a larger area.

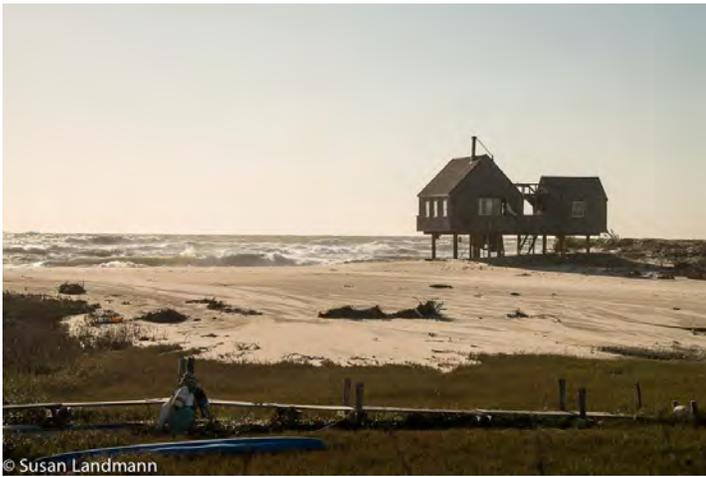
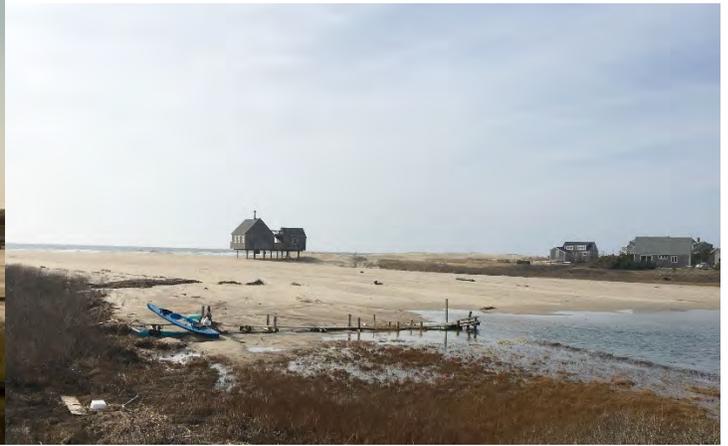
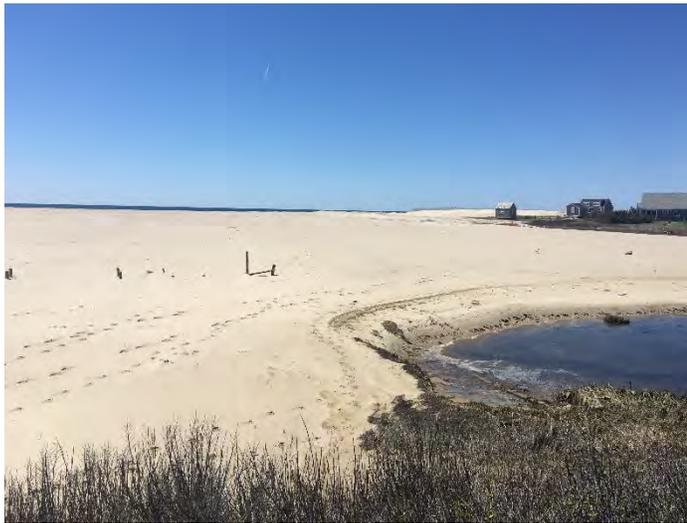
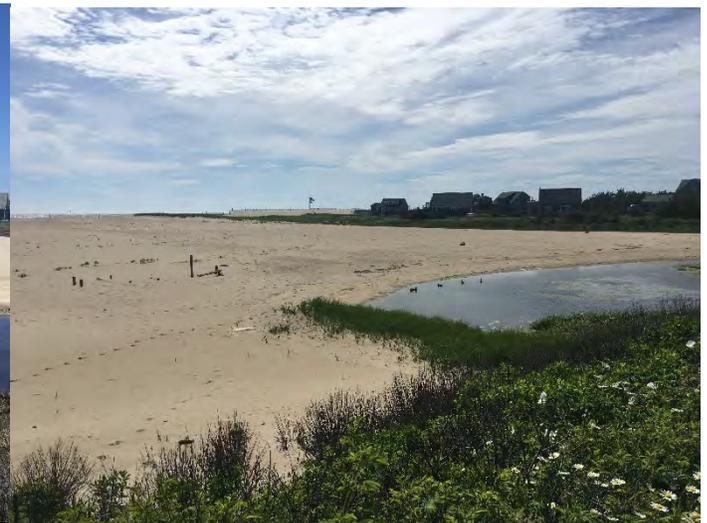
In addition to daily tidal cycles moving sand further into Millie's Pond, additional storm and high tides events occurred over the winter and early spring of 2018 that added more sand to the system and rearranged the existing deposited sand to cover even more of the remaining vegetation. Photos taken at approximately the same location on the eastern end of Millie's Bridge show a private dock that had initially escaped coverage by sand (Figure 4). By January 2018, the sand had advanced just to the edge of the private dock and by April 2018, after additional storm events, the dock is buried by sand. By July 2018, the dock is still buried by sand although some of the bordering salt marsh vegetation can be seen growing through the sand.

**Figure 4:** Photos taken from approximately the same spot on the eastern end of Millie's Bridge showing changes in sand extent, loss of the Stilt House and salt marsh vegetation over time. (Photo credit to Susan Landmann for the Oct 2017 photo).

Resampling of vegetation plots in July 2018 showed very little of the original vegetation able to grow through the thick sand deposits. As seen in the photos in Figure 4, salt marsh cordgrass (*Spartina alterniflora*) was able to grow through sand near Millie's Bridge, although these deposits happened later in the winter and may not have been as thick as the initial deposits.

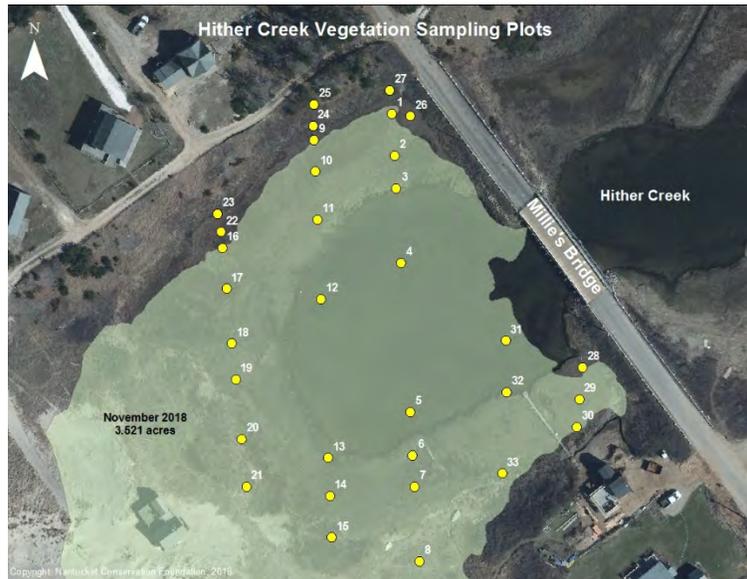
**Figure 5:** Vegetation sampling plots located along transects covering the deposited sand and surround wetland areas

Initial sand deposits buried a significant portion of the natural vegetation communities surrounding Millie’s Pond including shrub wetlands and salt marshes. To monitor the long term impacts to these habitats, we established transects across the sand and adjacent wetlands to monitor vegetation growth through the sand and vegetation colonization on the new sand substrate (Figure 5). Plots were sampled in November 2017 to document areas where vegetation survived the initial sand burial event and then again in July 2018 to document colonizing and surviving areas of vegetation.

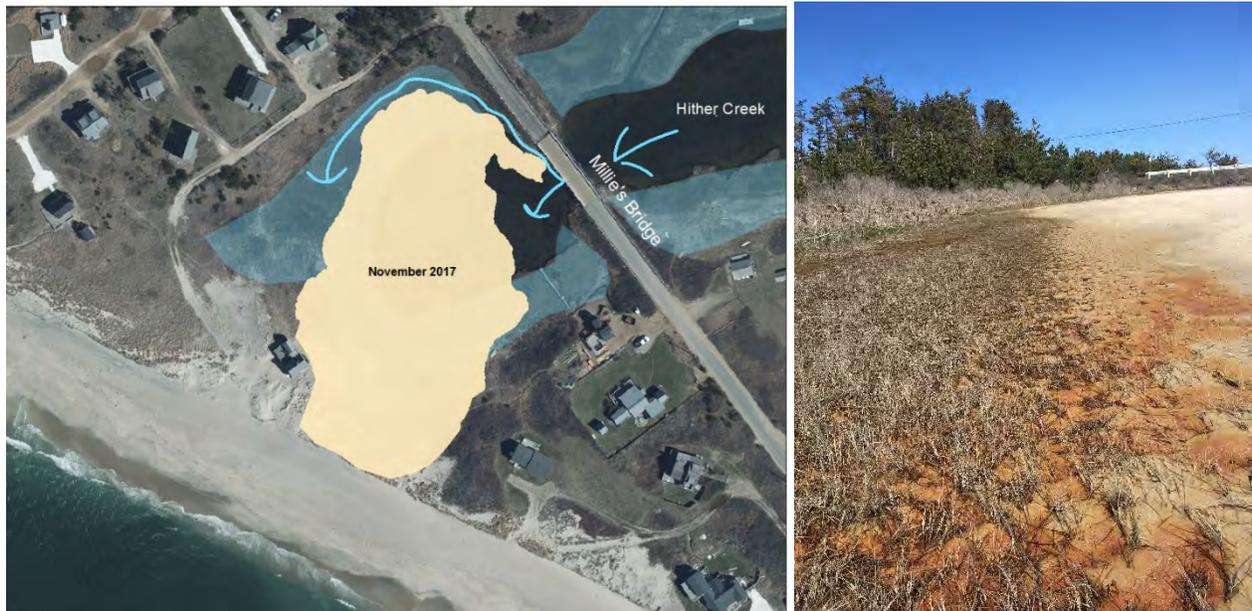
As previously mentioned, sand continued to advance over the winter and many of those salt marsh areas were covered by at least some amount of sand by July 2018. In addition to the advancing sand front, these salt marsh areas became the path of preferential water flow as tides rose and fell into Millie’s Pond from Hither Creek (Figure 6). The salt marshes were at a lower elevation than the surrounding sand deposition so tides preferentially moved over and remained in these wetlands. These marshes were a mix of high marsh (adapted to only occasional flooding by water) and low marsh (adapted to daily flooding) prior to the sand deposition. High marshes are more susceptible to tides and flooding so as tidal waters continually moved over these areas, the high marshes died out leaving bare muck sediments that will hopefully be colonized by low marsh vegetation in the future.

**Figure 6:** Map showing preferential flow of water onto surrounding salt marshes. Those salt marshes areas were dead in April 2018 but had been previously alive in November 2017.

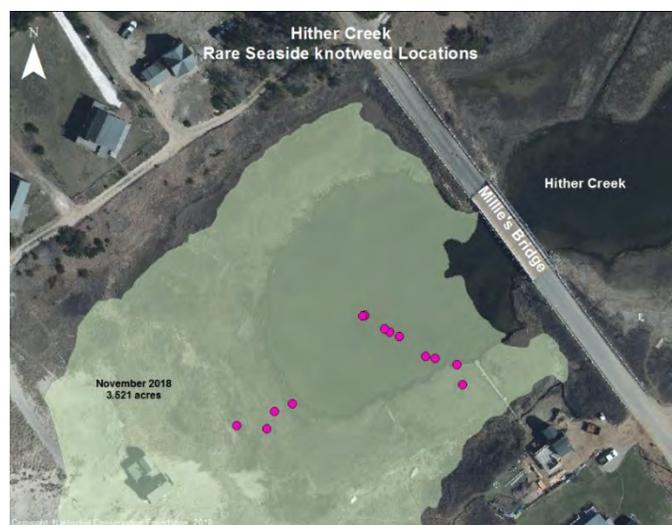
We did encounter and document a healthy population of a state-listed species of special concern that likely seeded in from populations elsewhere such as Eel Point. Seaside knotweed (*Polygonum glaucum*) was able to grow and established a seed setting population on the sand face (Figure 7).

**Figure 7:** Seaside knotweed populations found growing and setting seed on the new sand substrate at Hither Creek July 2018 (pink dots represent areas of 1-5 plants).
